## **DRONE INSPECTION REPORT**

06/06/2018

Catholic Church

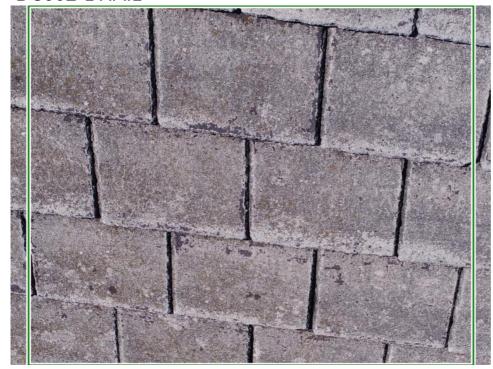
## DC002-1 HAIL

Hail damage to this surface.

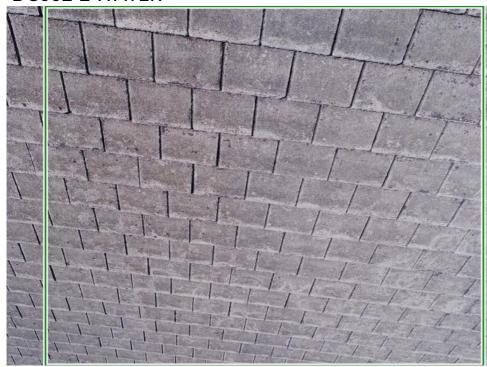
## DC002-2 WATER

Wear on shingles.

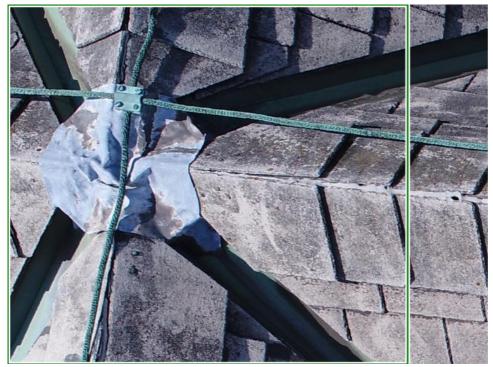
#### PO002-1 OTHER

Damage to roof.

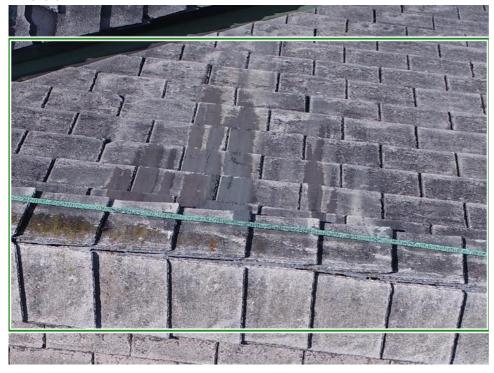
## PO002-2 WATER

Wear on shingles.

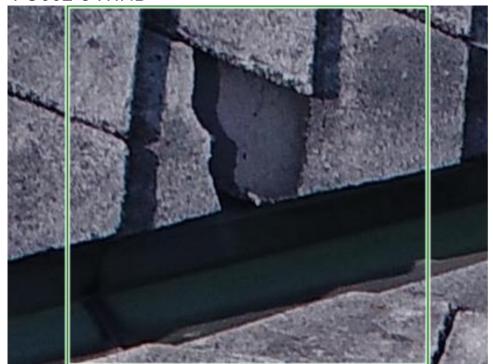
## **PO002-3 WIND**

Jed 06/07/2018 12:10 EDT -0400 Beck Damage to shingle.

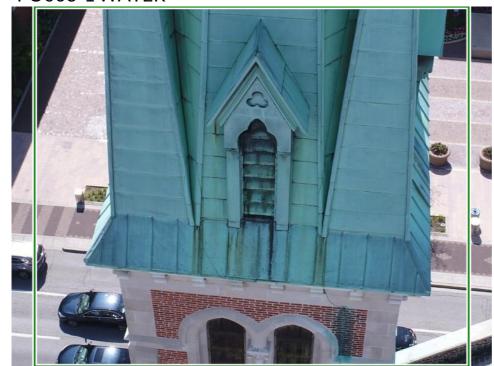
## PO003-1 WATER

Copper caps

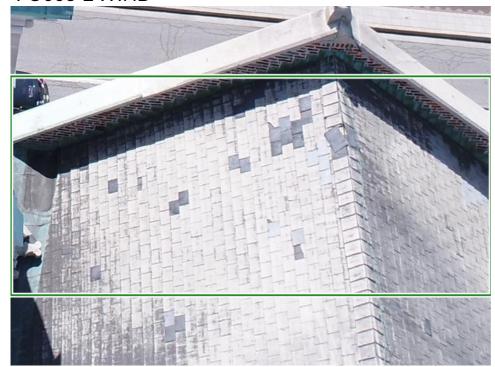
# PO003-2 WIND

Missing Shingles

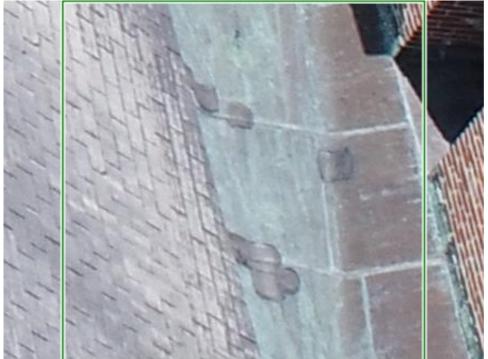
#### **PO003-3 WIND**

Jed 06/07/2018 12:07 EDT -0400 Beck Shingles in valley.

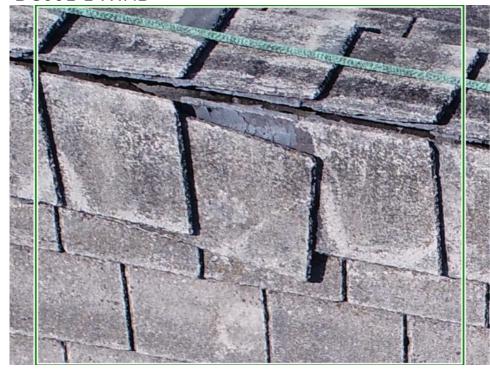
## DC001-1 WIND

Jed 06/07/2018 12:08 EDT -0400 Beck Shingle falling.

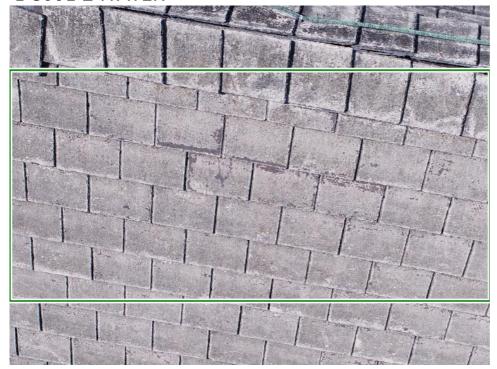
## DC001-2 WATER

Wear on shingles.

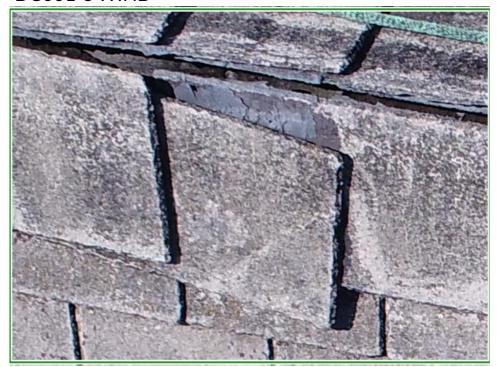
# DC001-3 WIND

Wind damage.

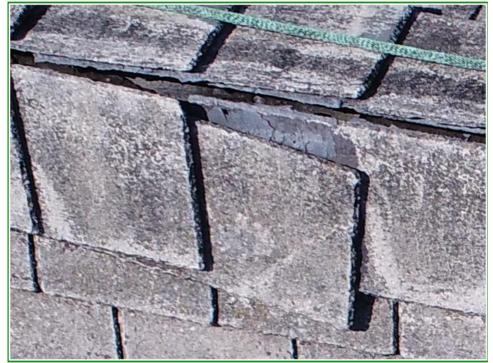
#### DC001-4 WIND

Wind damage to roof.

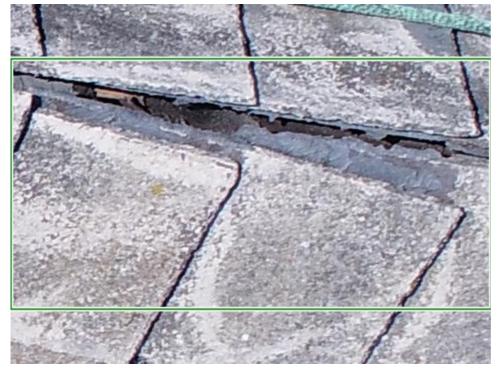
# DC001-5 WIND

Issue with shingle.

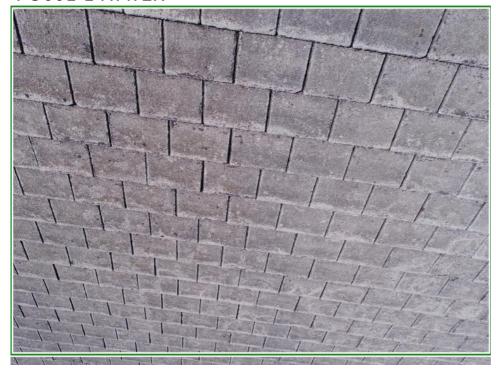
## PO001-1 WATER

Wear on shingles.

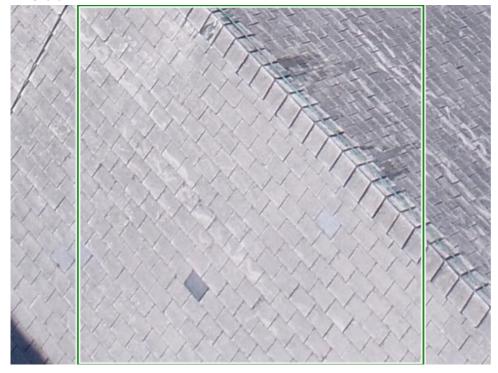
## PO004-1 WIND

Missing shingle.

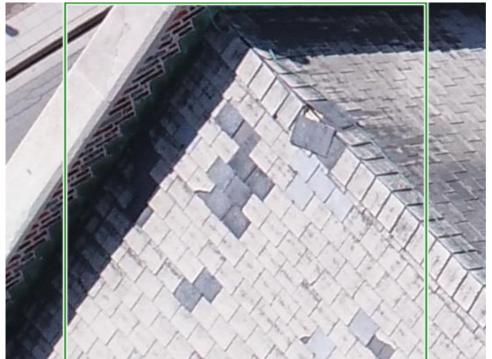
#### PO004-2 OTHER

Nigel 06/07/2018 12:46 EDT -0400 Parfitt Missing Shingles
